Manhole Inspection Summary

Manhole # S29II2001MH

Insp Date: **3/28/07 10:04 AM**

Location Address: **6003 CHARLES ST**

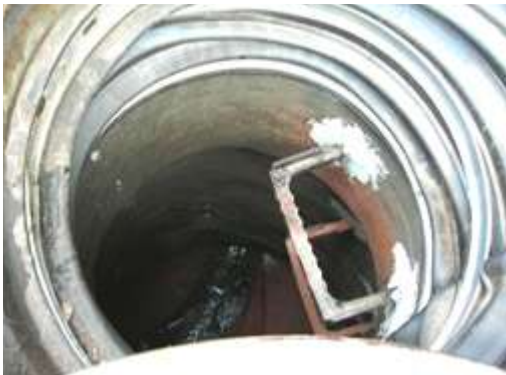
Defect

Infiltration: ☐ None ☒ **Joint** ☐ Cracks ☐ Mortar ☐ Roots ☐ Wall

Infiltration: ☐ None ☐ Joint ☐ Cracks ☐ Mortar ☐ Roots ☒ **Wall**

Adjustment and Corbel infiltration - other side.

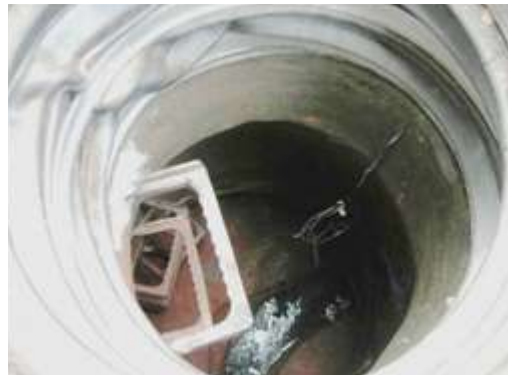
Defect

Adjustment and Corbel infiltration.

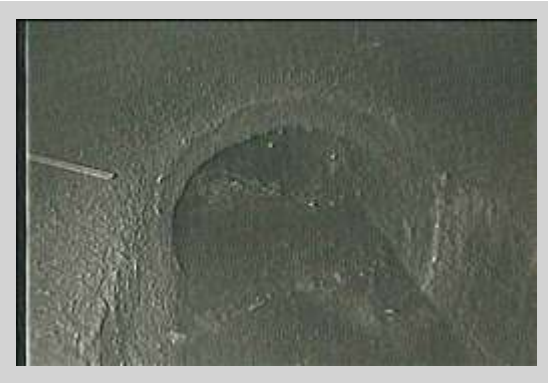
12 in. Circular Gravity Sewer Pipe Out @ 12 O'Clock

Deposits: ☐ None ☒ **Mud** ☐ Sludge ☒ **Debris** ☐ Grease

Silt Depth: **1** (in.) Deposits Extent: **Light**

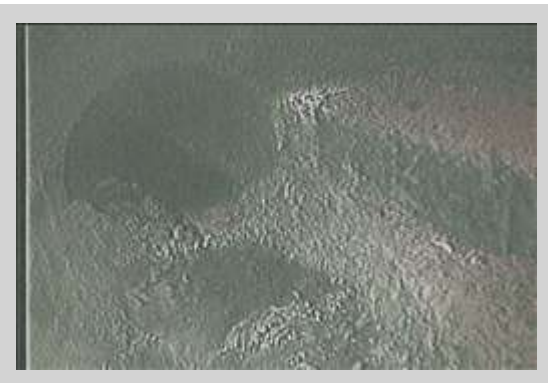
12 in. Circular Gravity Sewer Pipe In @ 4 O'Clock

Deposits: ☐ None ☒ **Mud** ☐ Sludge ☒ **Debris** ☐ Grease

Silt Depth: **2** (in.) Deposits Extent: **Light**
